Subjects: Dock and Sea Trials "RTA 1" Catamaran Passenger Ferry
Metal Shark Franklin, LA.

The following was observed during my visit of April 27, 2018

First Catamaran Ferry "RTA 1"

Two (2) 32.0 (m) X 7.7 (m) X 1.35(m)RTA Passenger Ferries

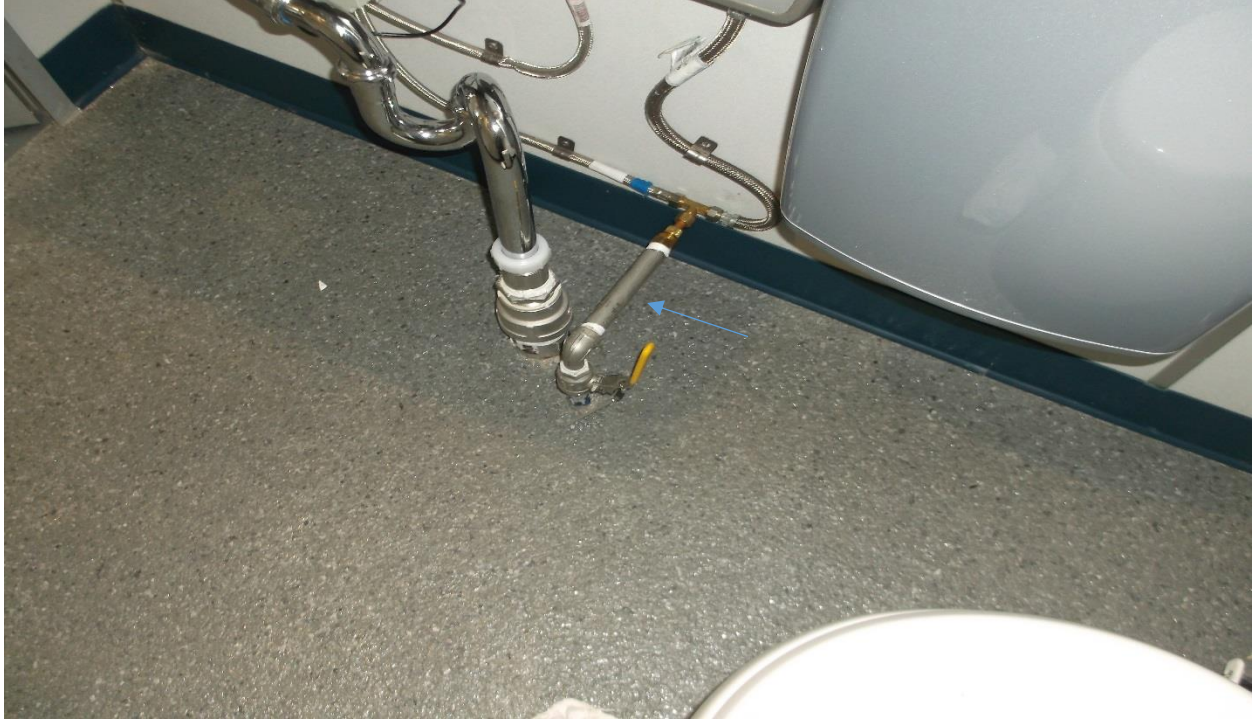
9. The standard head toilet should have water in the bowl and requires adjustment. The water supply valve and associated piping is exposed and could be damaged and/or broken if stepped on.

View of exposed water piping under sink of standard head

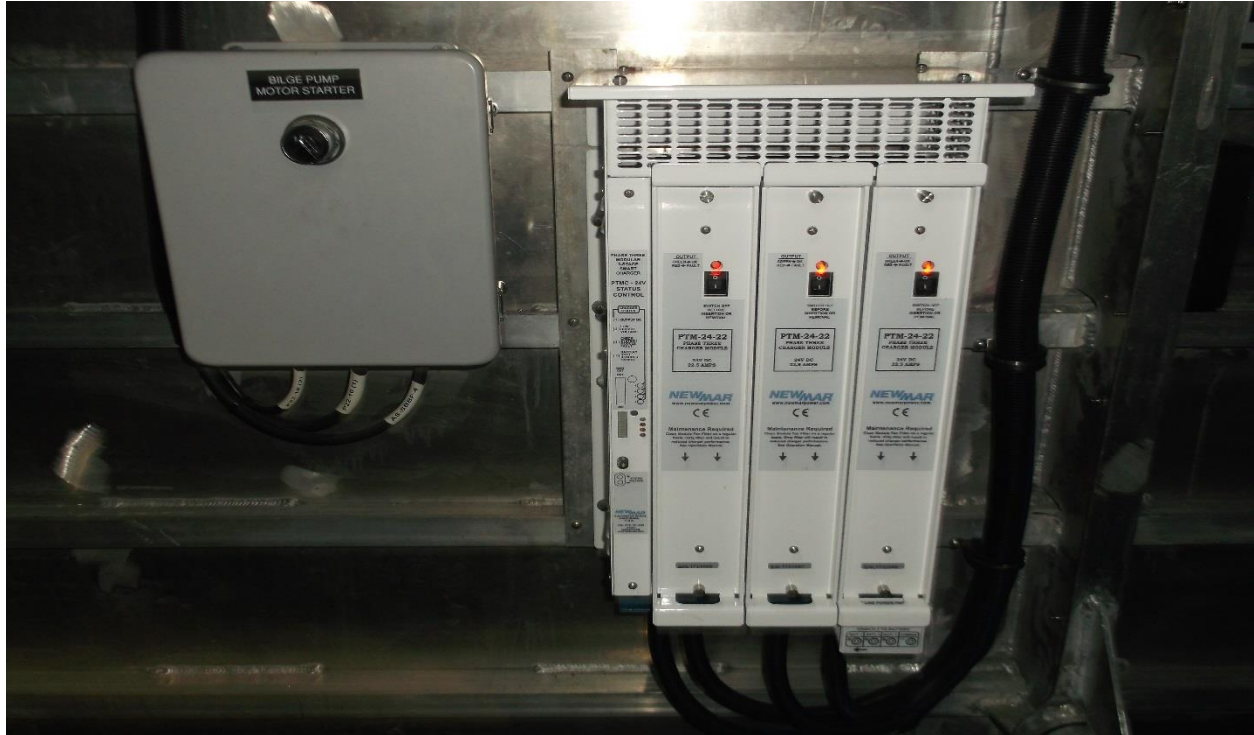
3. Number 2 starboard hull void having areas with grating clamps loose in need of tightening.
4. Number 3 port and starboard hull voids having the lower access ladder grating without securing clamps. The charger electrical panels were without identification label.

Typical view of electrical charger unit without labeling inside no.3 port & starboard voids

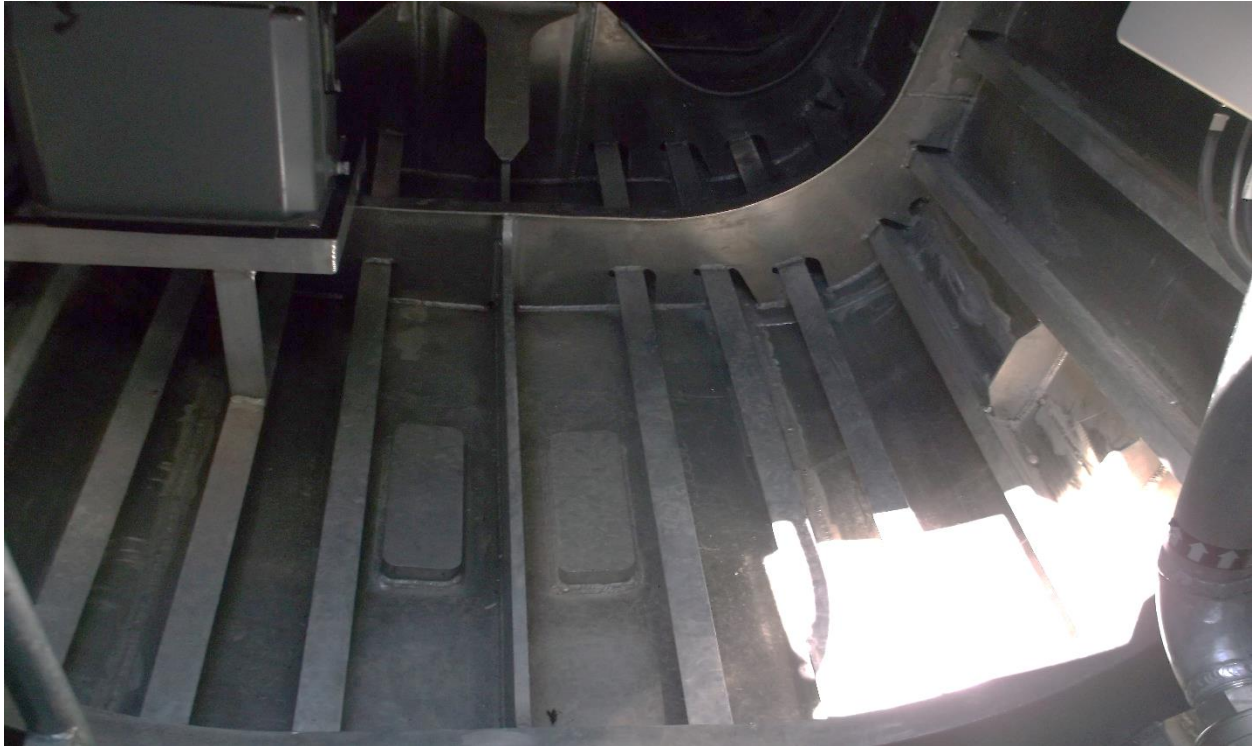
View of no.5 starboard steering gear void without grating

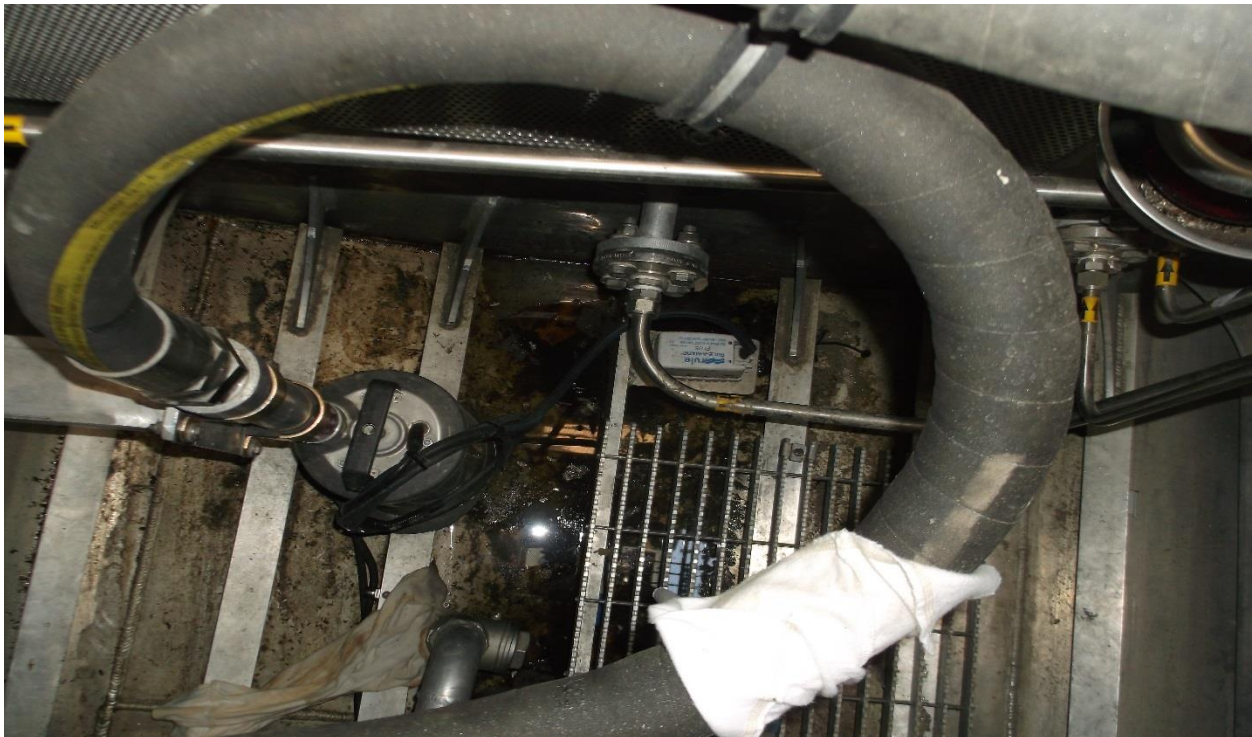
5. Number 4 port and starboard hull machinery spaces were observed not clean having dirt, trash and other debris with areas of dirty water in the bilges. A placard needs to be installed for operation of the bilge pump valves in order to use as a secondary fire pump. The control valves are not easy to find and/or operate as their location is behind the part of the exhaust system.

View of lower bilge areas inside machinery spaces with water, dirt and debris

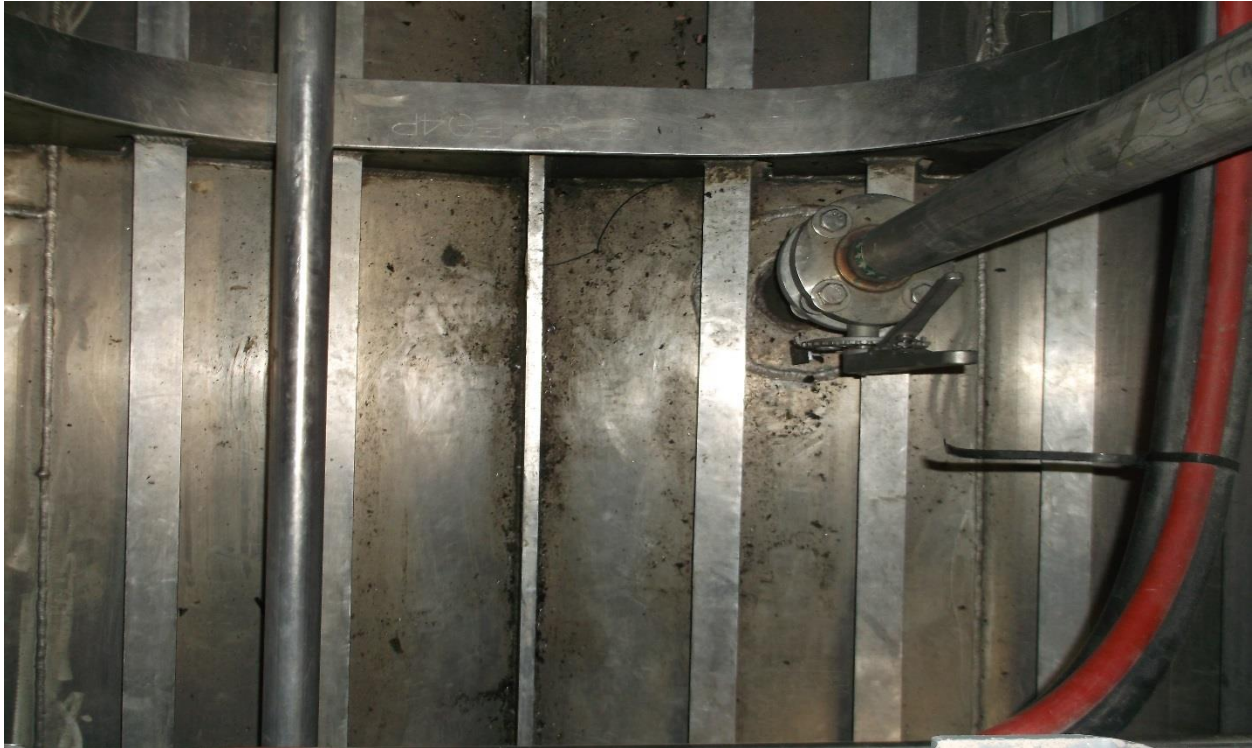
Another view of dirt and debris in bilge of machinery space

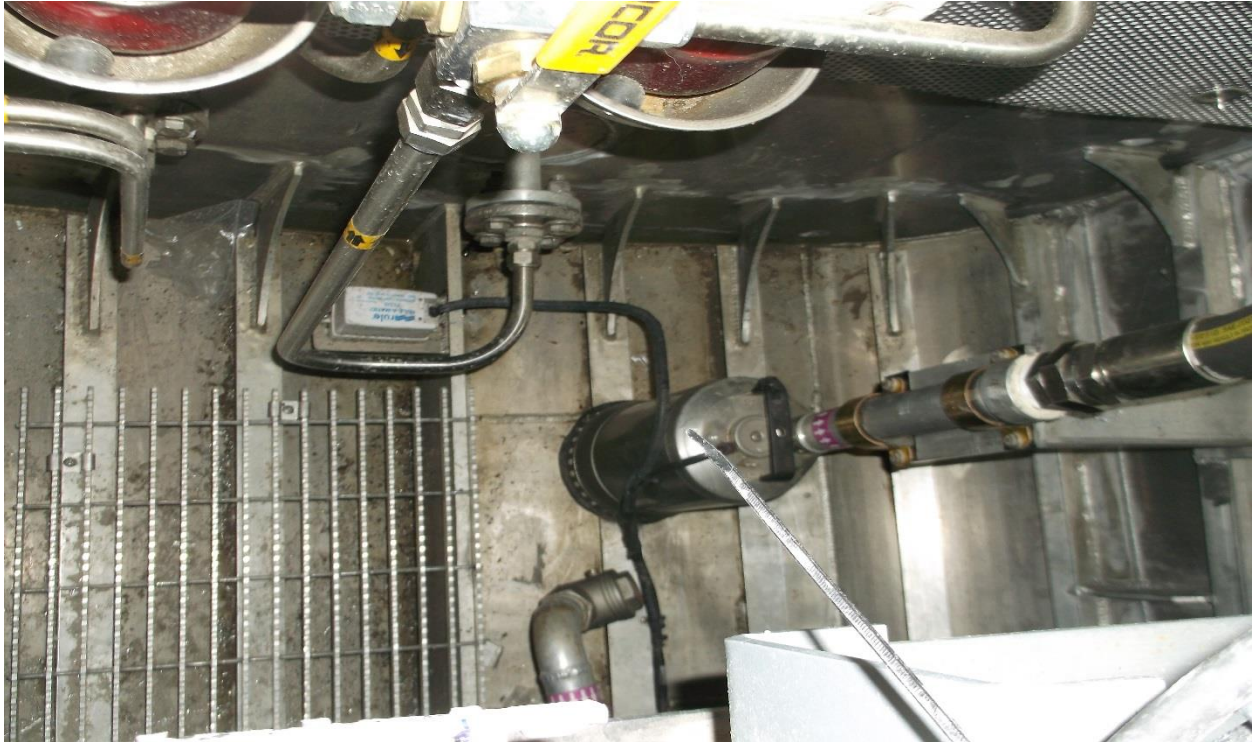
Another view of dirty bilge area inside machinery spaces

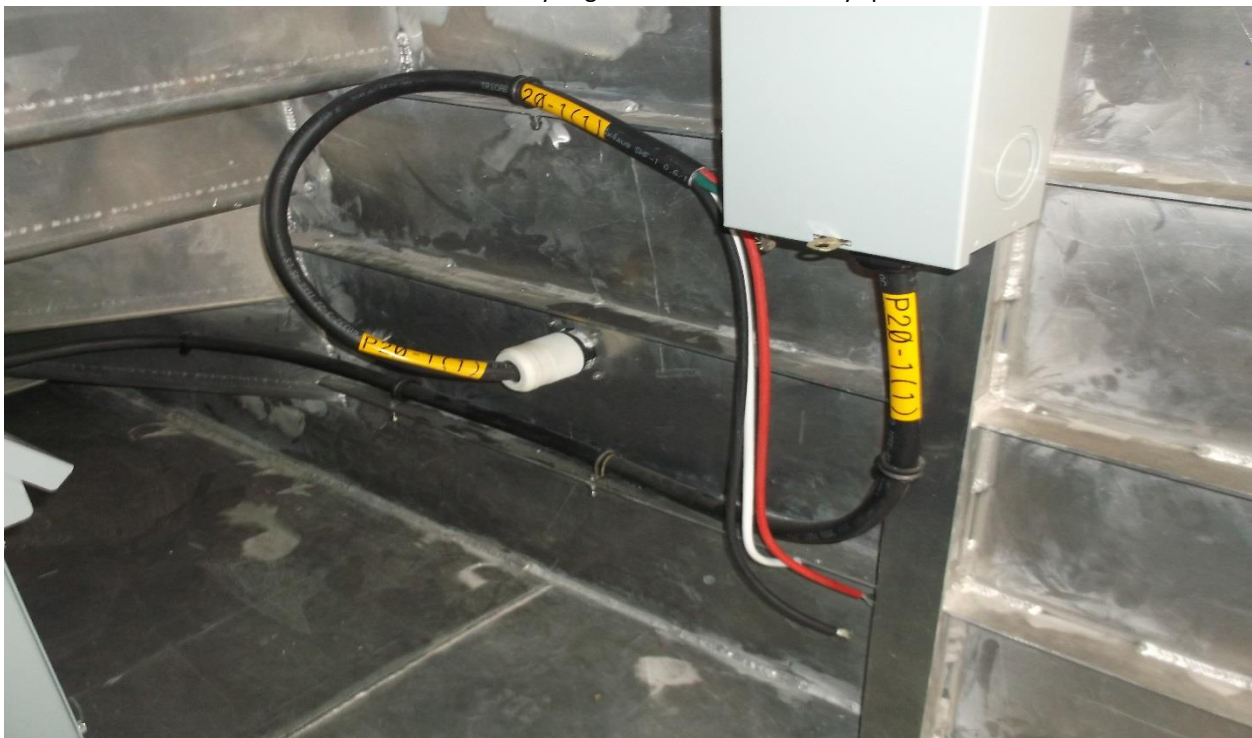
Aft main deck storage room shore power cable not connected and lacking ID labels on panel and receptacle boxes

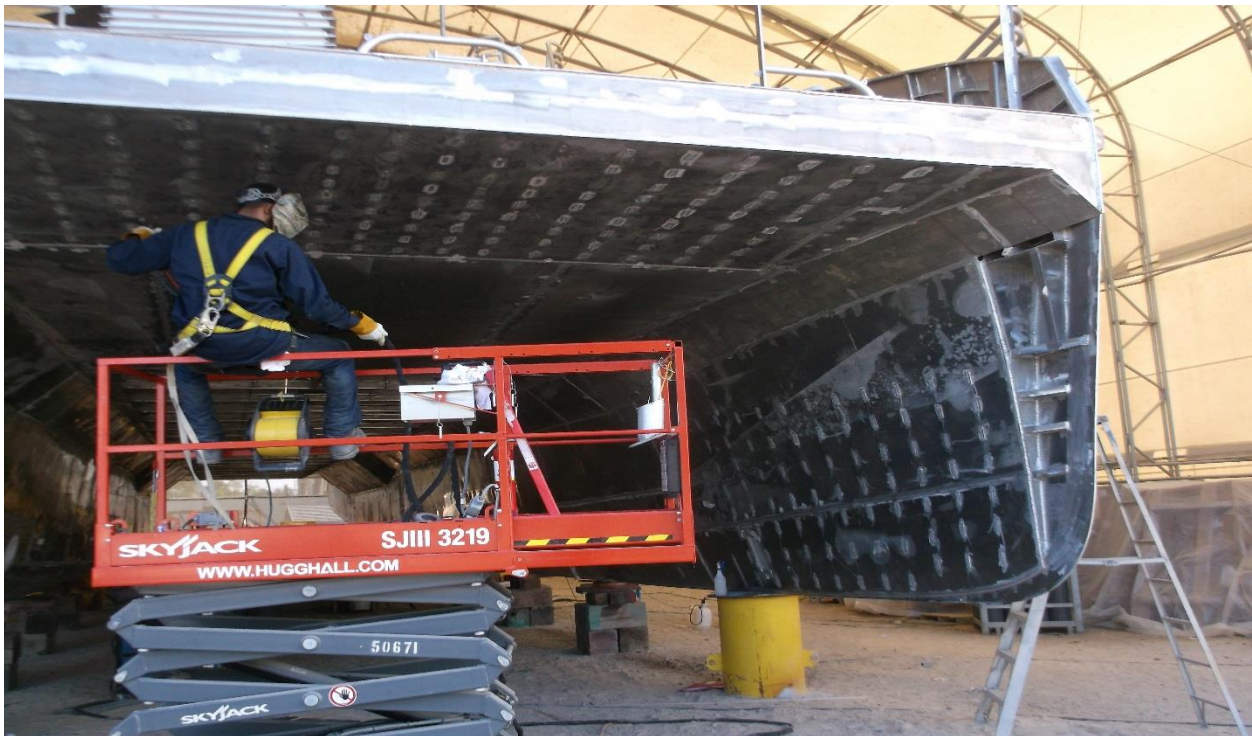
Forward center view having welder make repairs to underside of bridge area structure

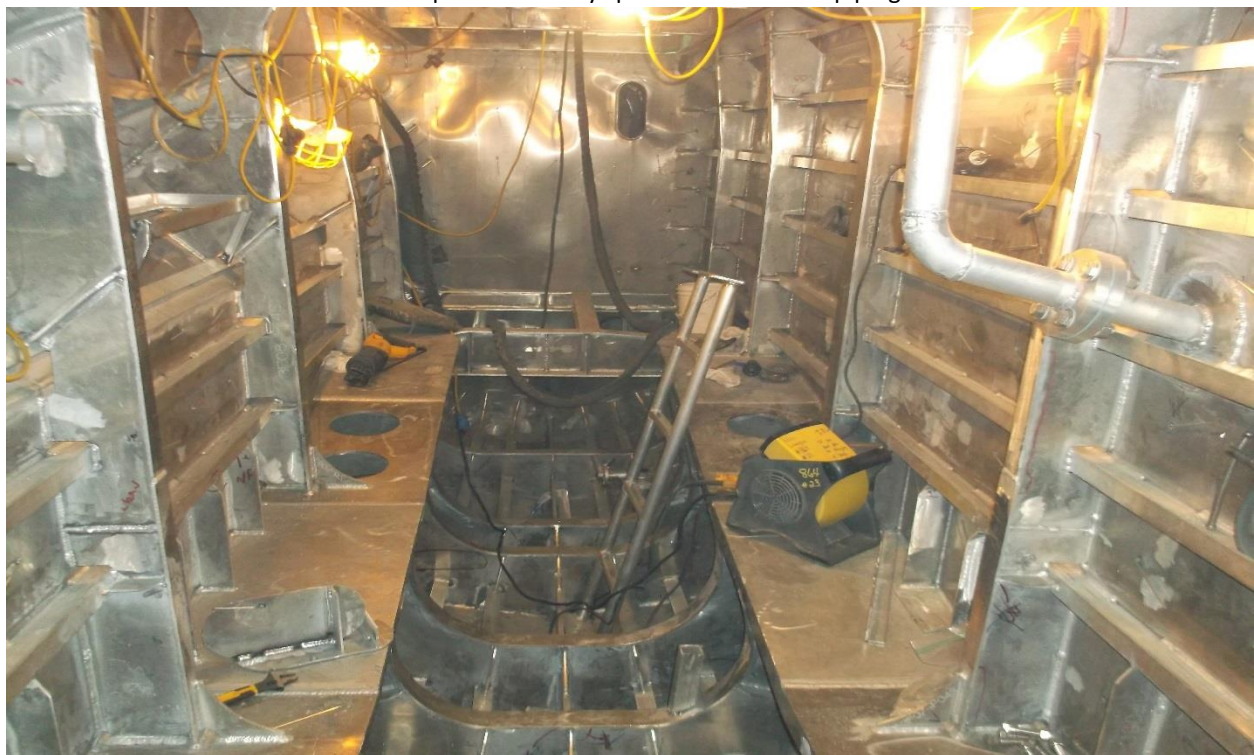
View inside starboard machinery space

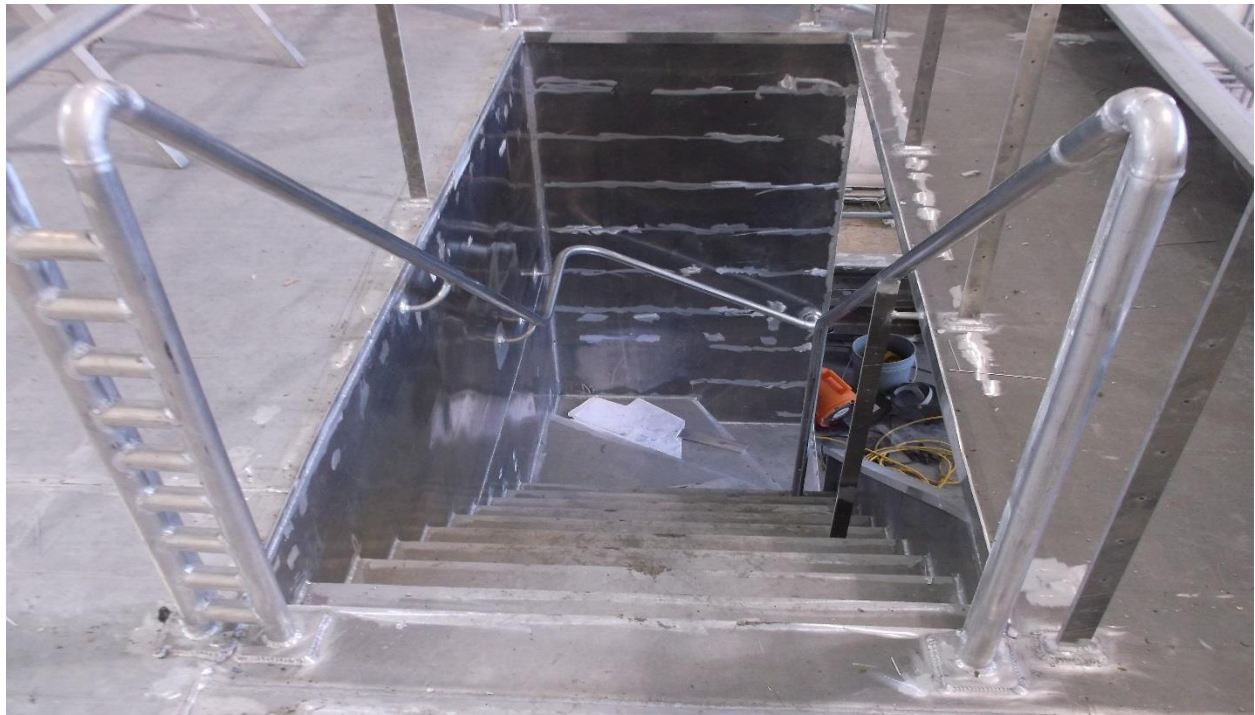
View from aft upper deck stairwell

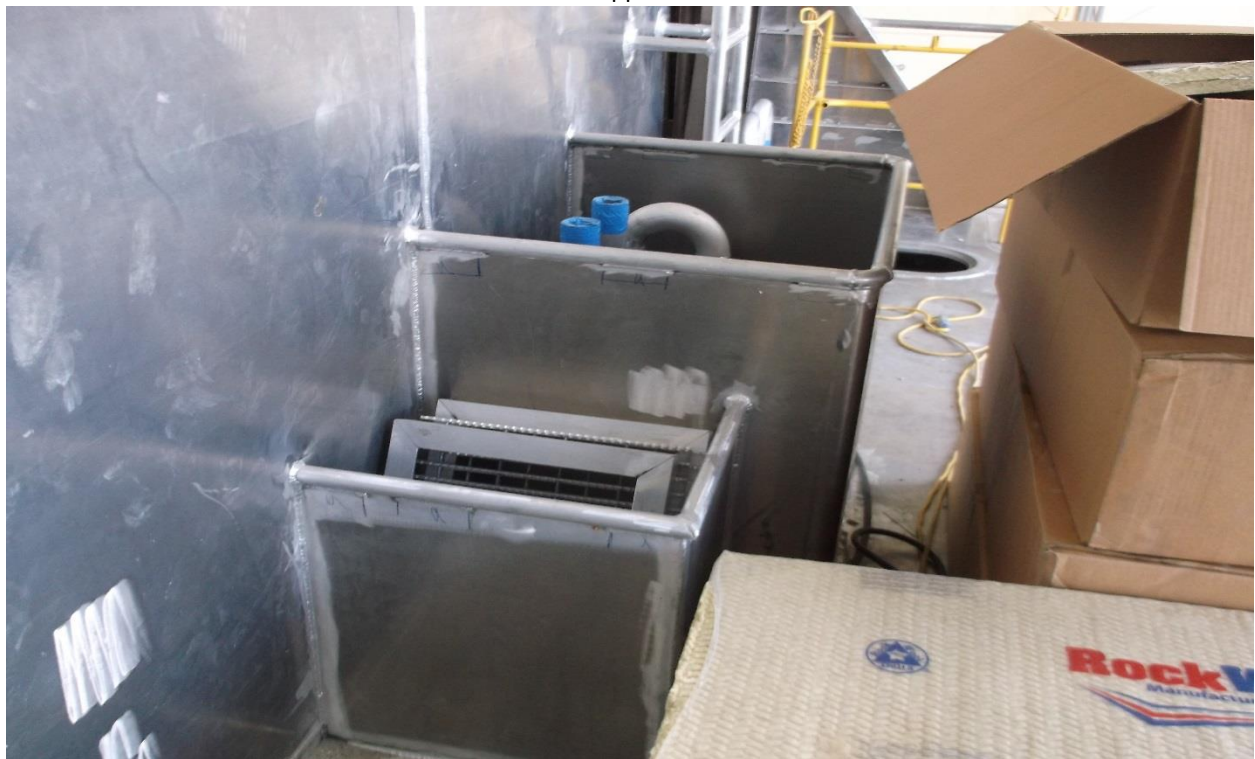
View of fueling containment and anchor line/chain storage area

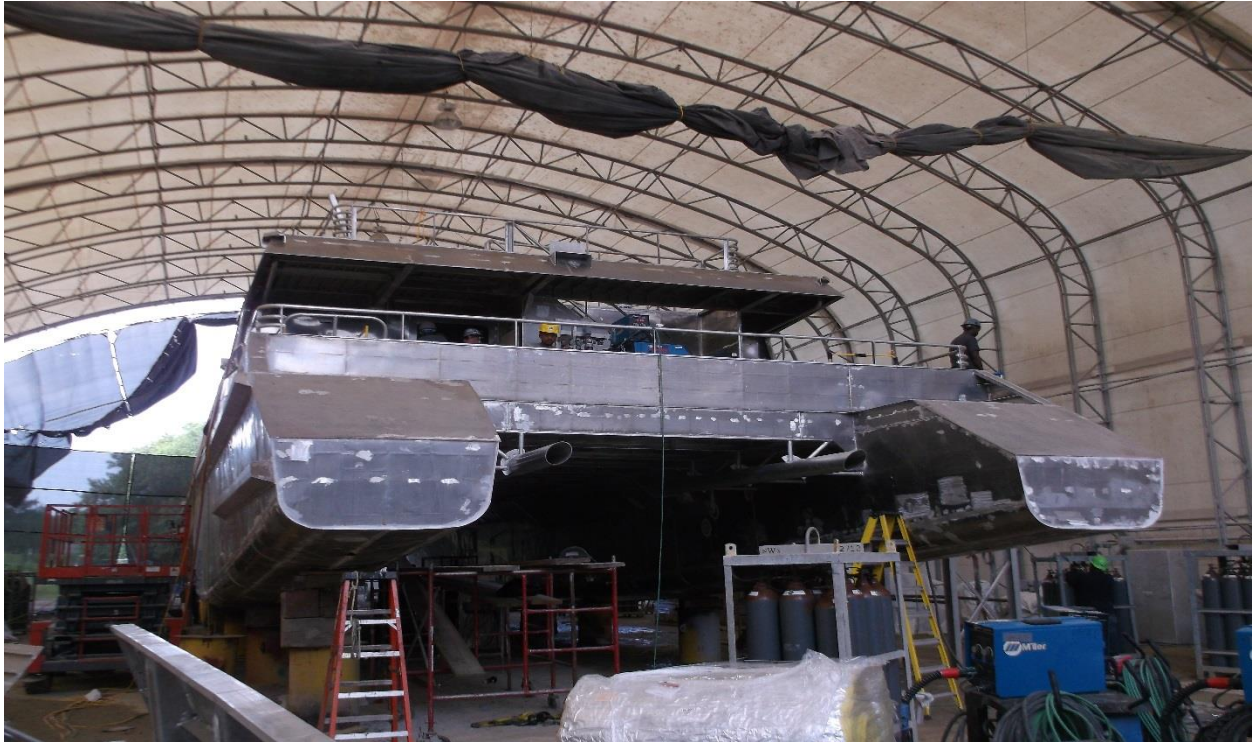
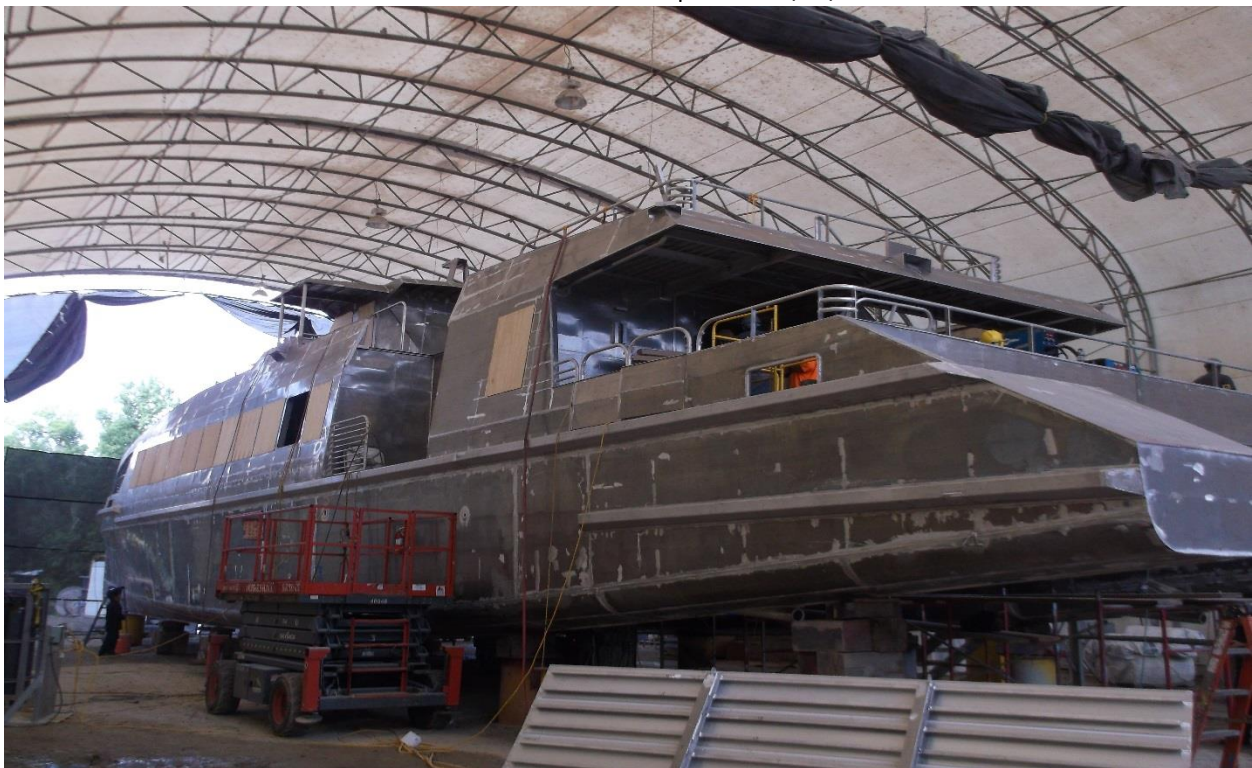
Views from the stern and aft port side 7/11/2018

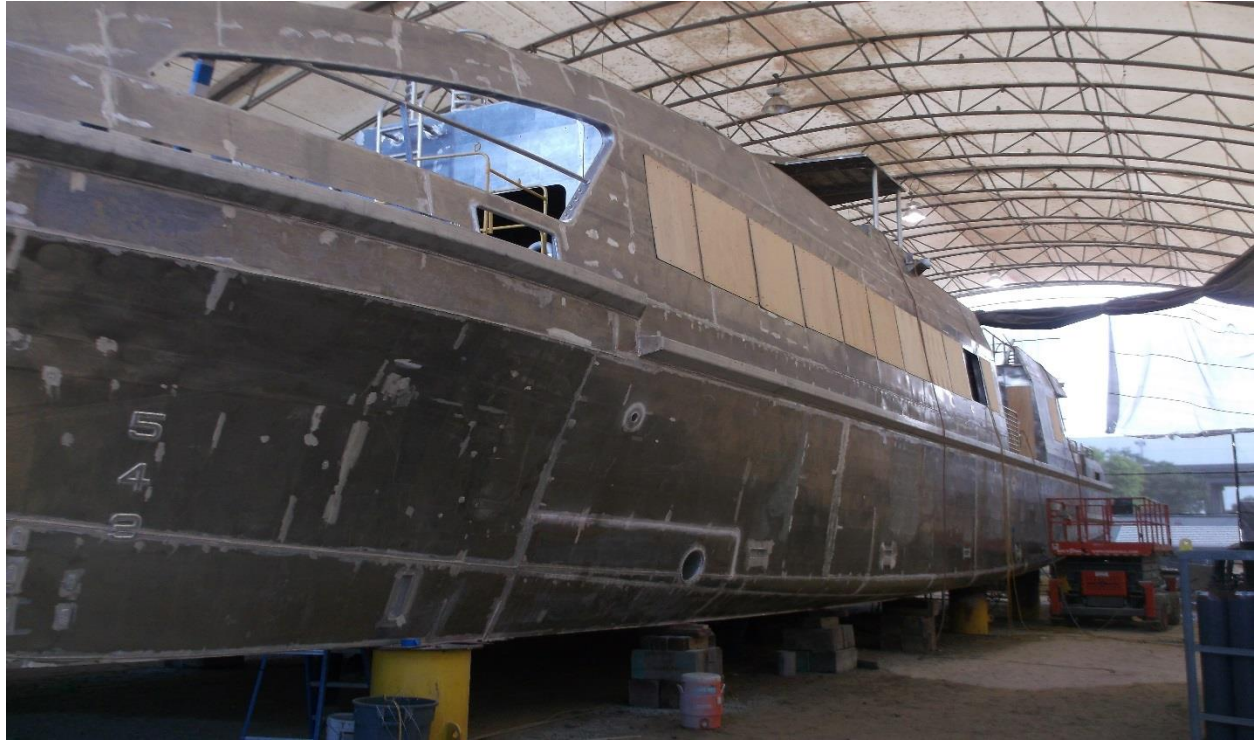
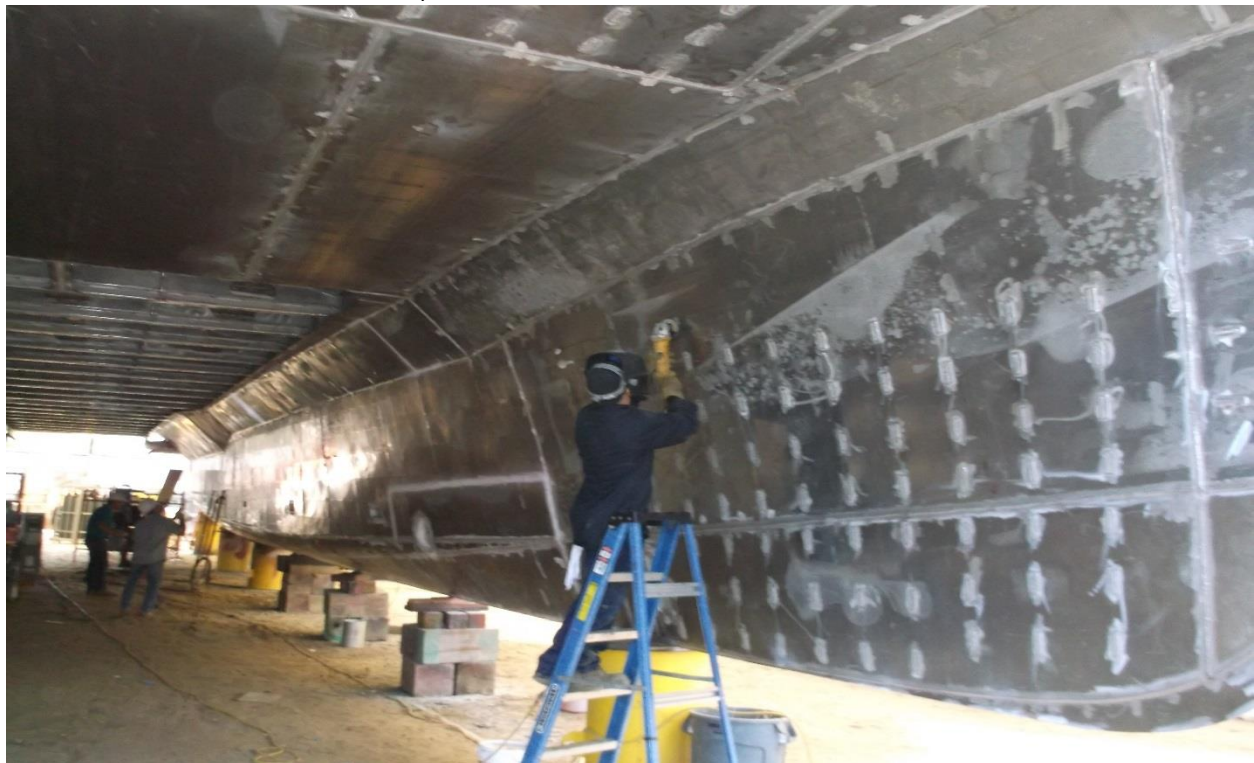
July 11, 2018 the vessel was working with Quality Control workers observing the port and starboard hull for discontinuities. The hull bottom seams having Liquid Penetrant/Penetrant Test (PT) performed was observed having previously marked discrepancies repaired with additional areas being marked during this time.

Views of port forward outboard and inboard sides of hull

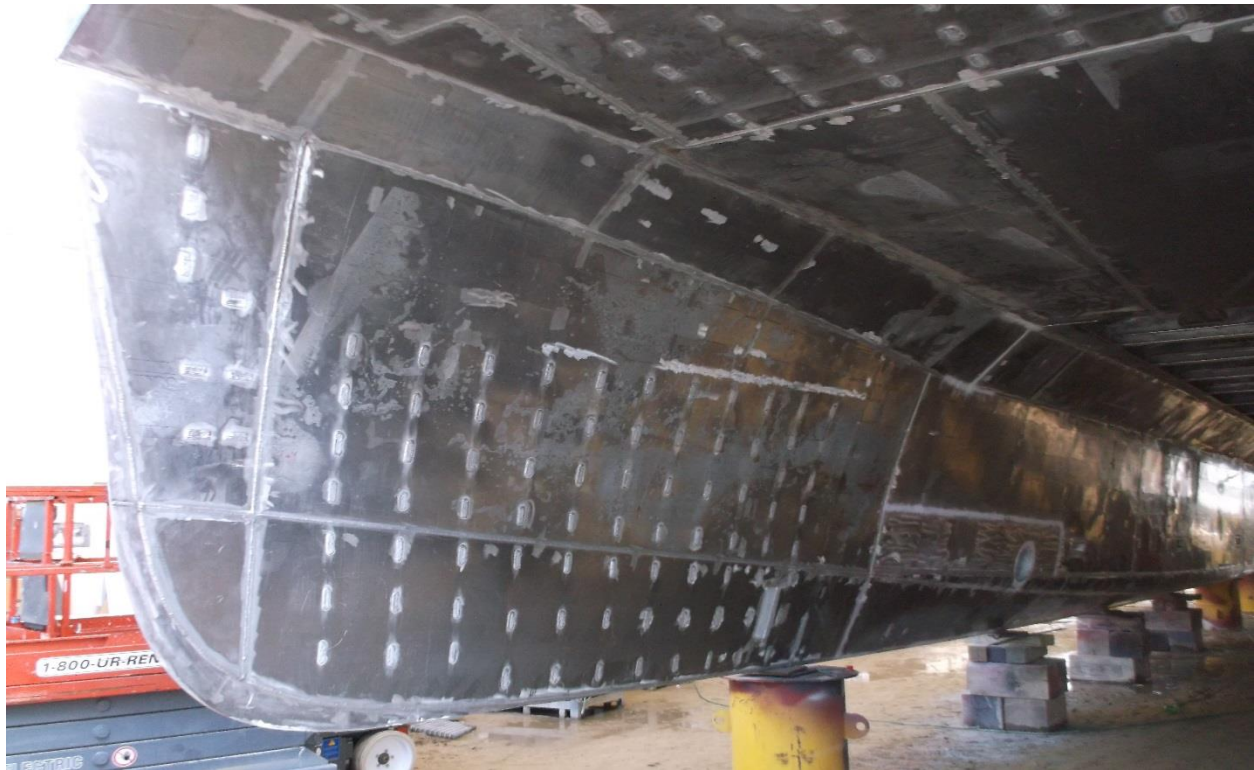
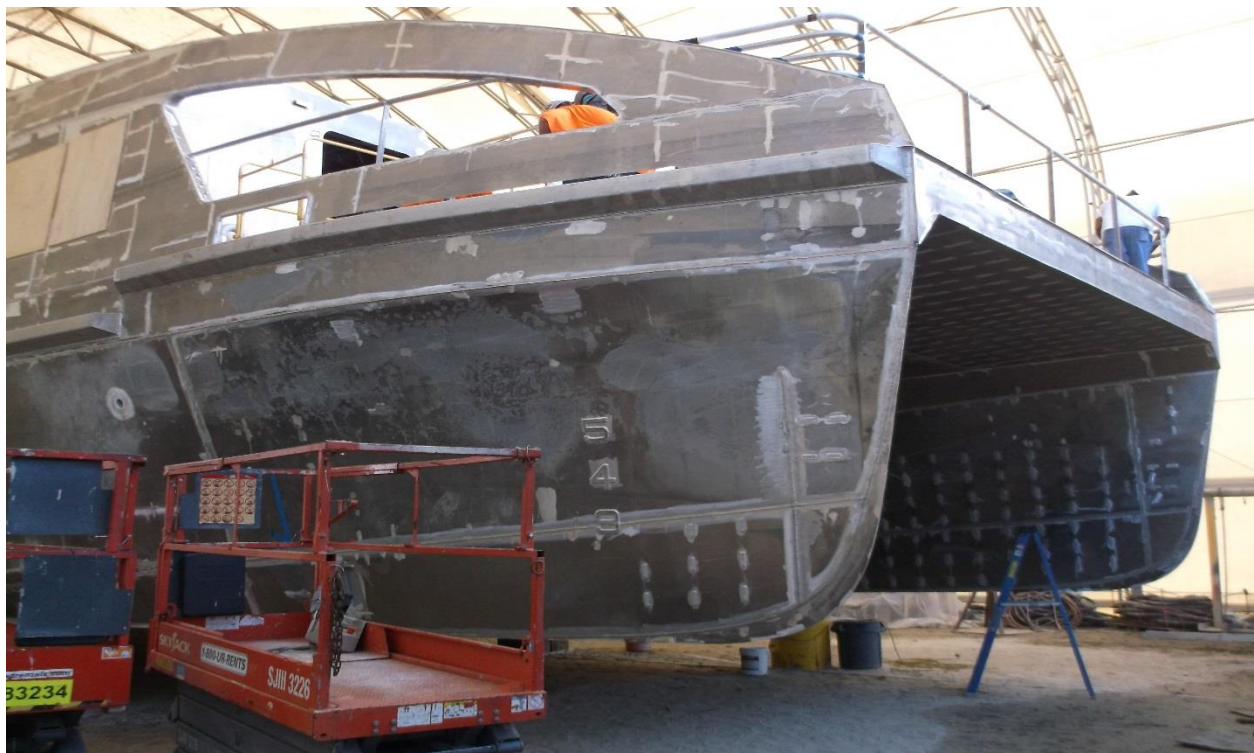
Forward inboard and outboard starboard hull side views

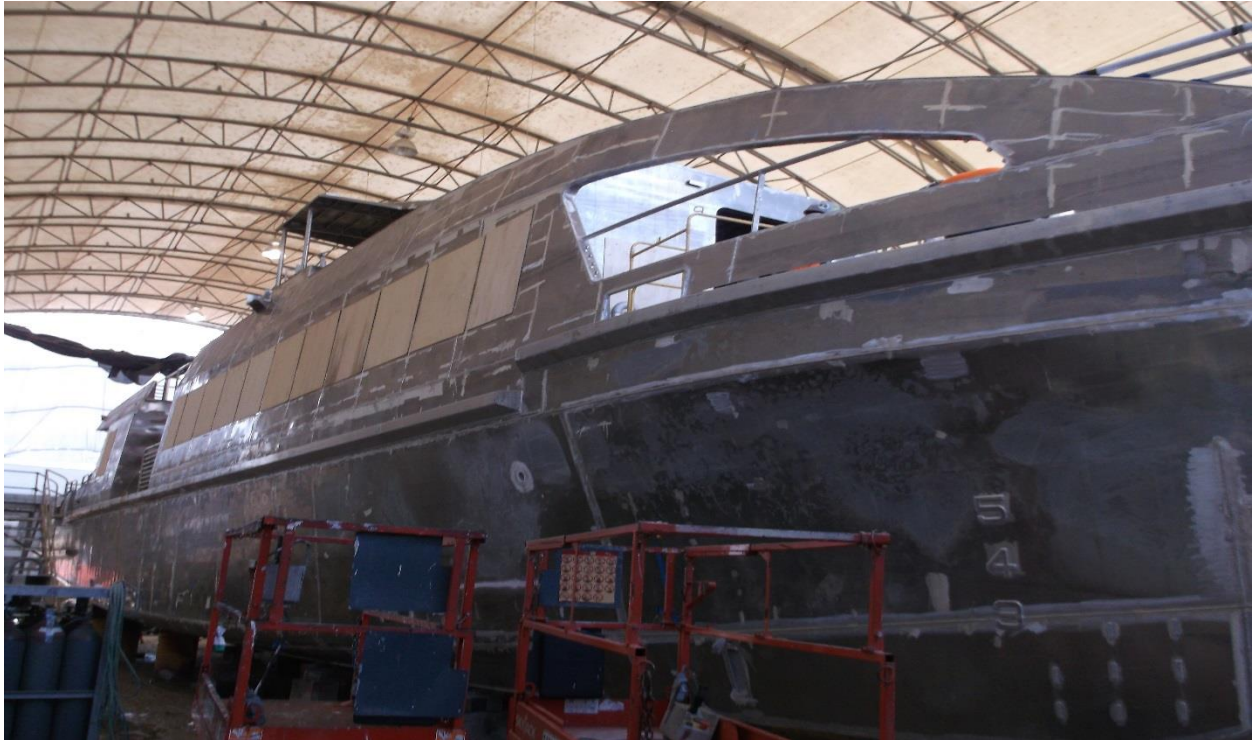
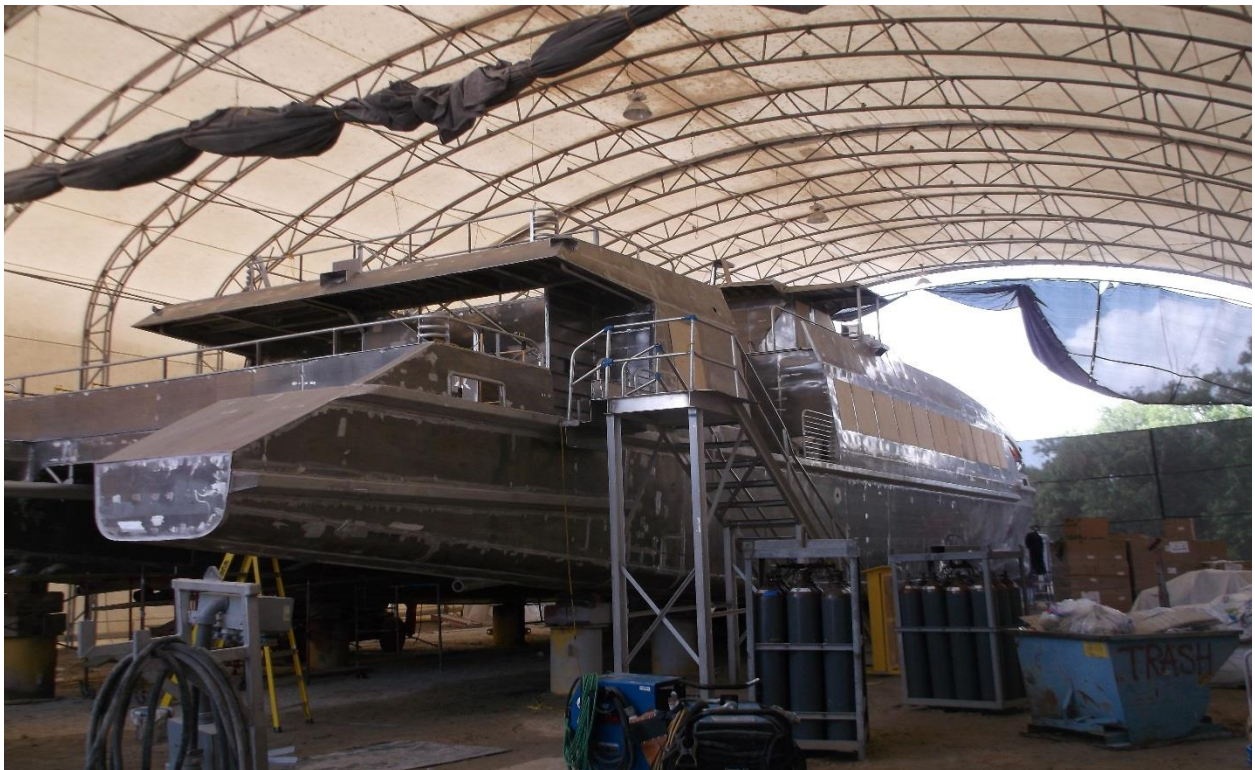
Overall forward and aft views of starboard side

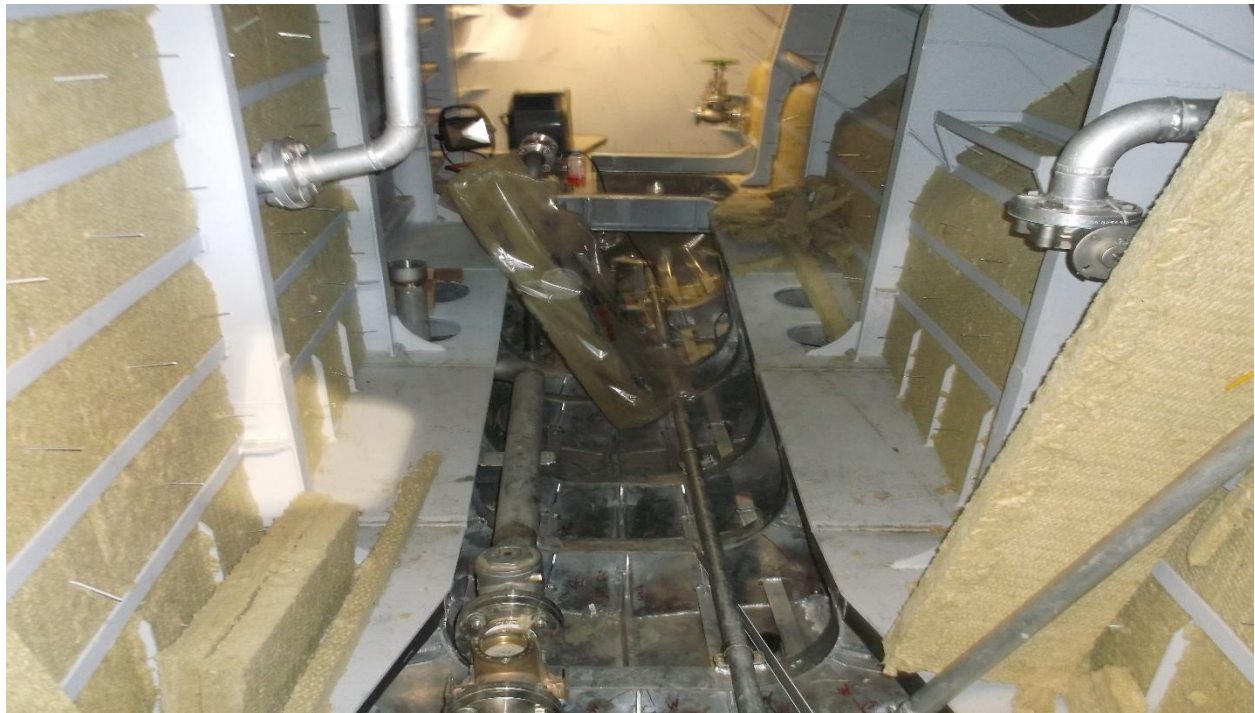
Number 4 port and starboard hull compartments (Machinery spaces) were observed having raw water (sea chest) piping and fuel oil piping installed. The internal inboard and outboard sideshell of the port machinery space having insulation board installed.

View of port machinery space looking forward having insulation installed at sideshell areas

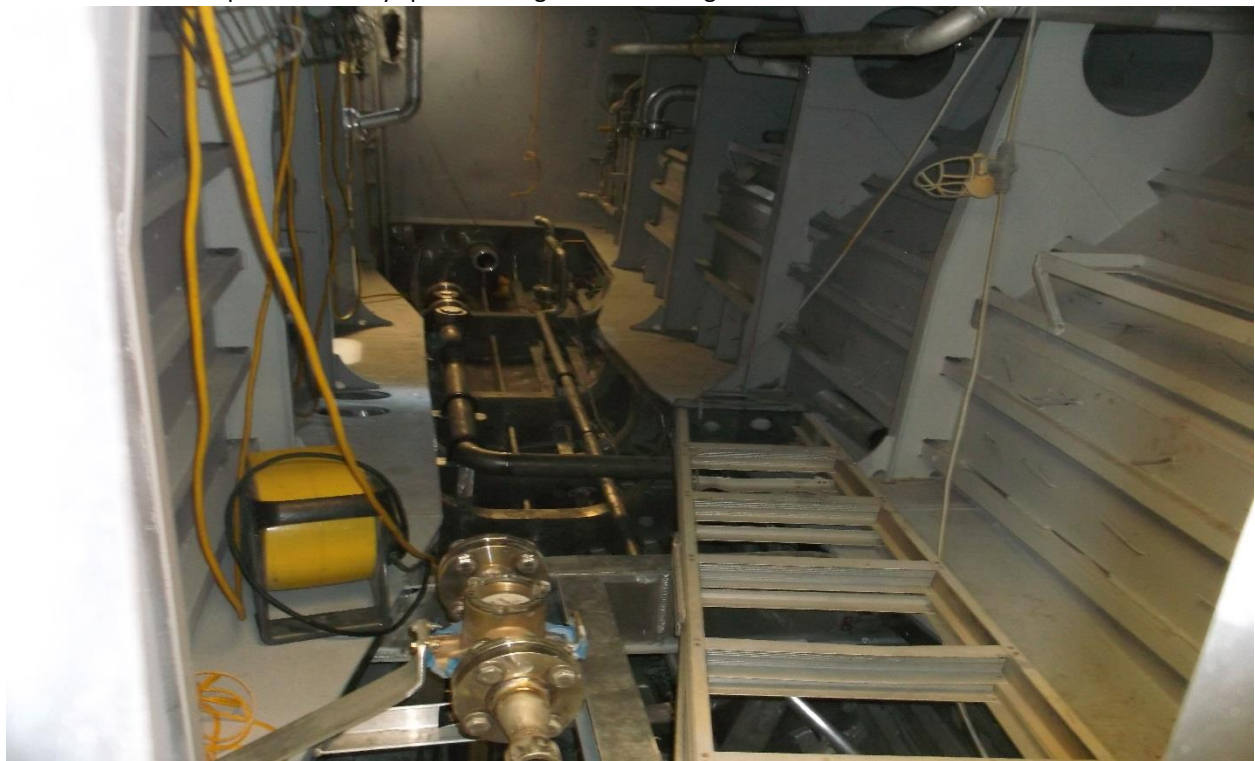
View of starboard machinery space looking aft with raw water piping and insulation pins installed

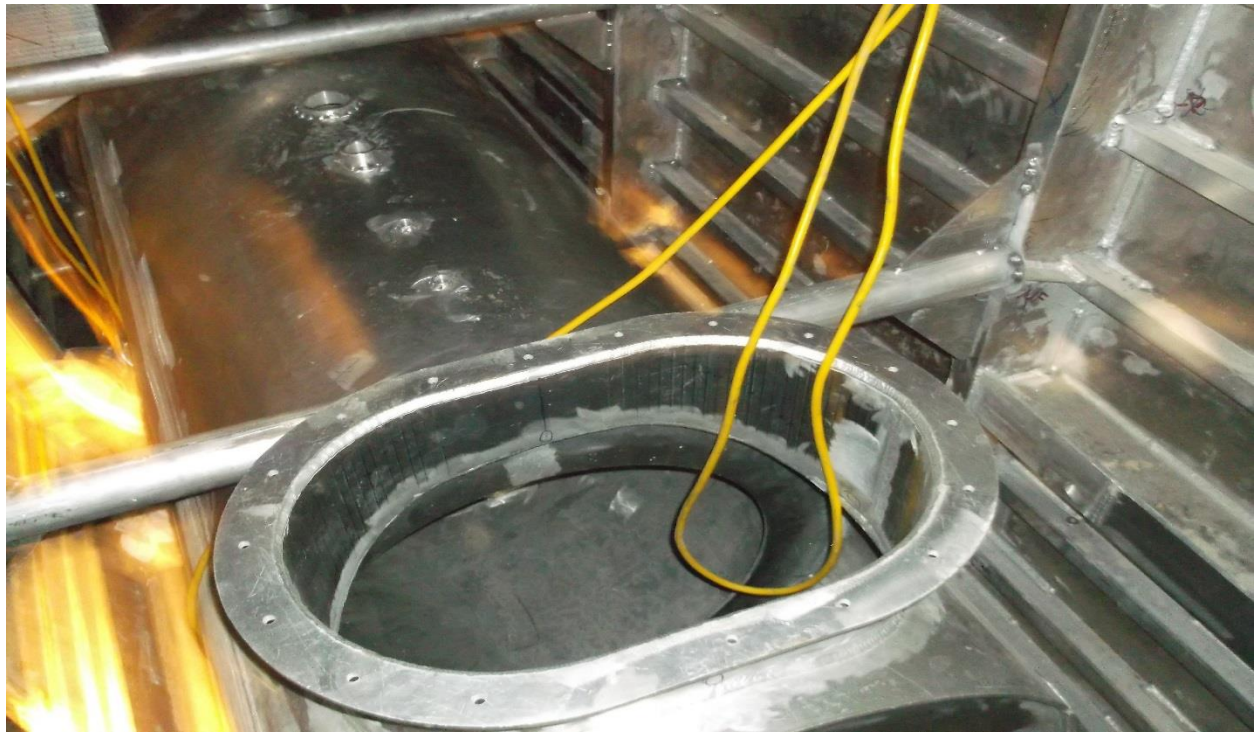
The number 3 starboard fuel oil tank compartment was observed having previous USCG required tank modifications welded complete and fuel oil piping 80% installing. The number 3 port compartment was not accessible.

Fuel oil tank modifications welded inside starboard no.3 compartment

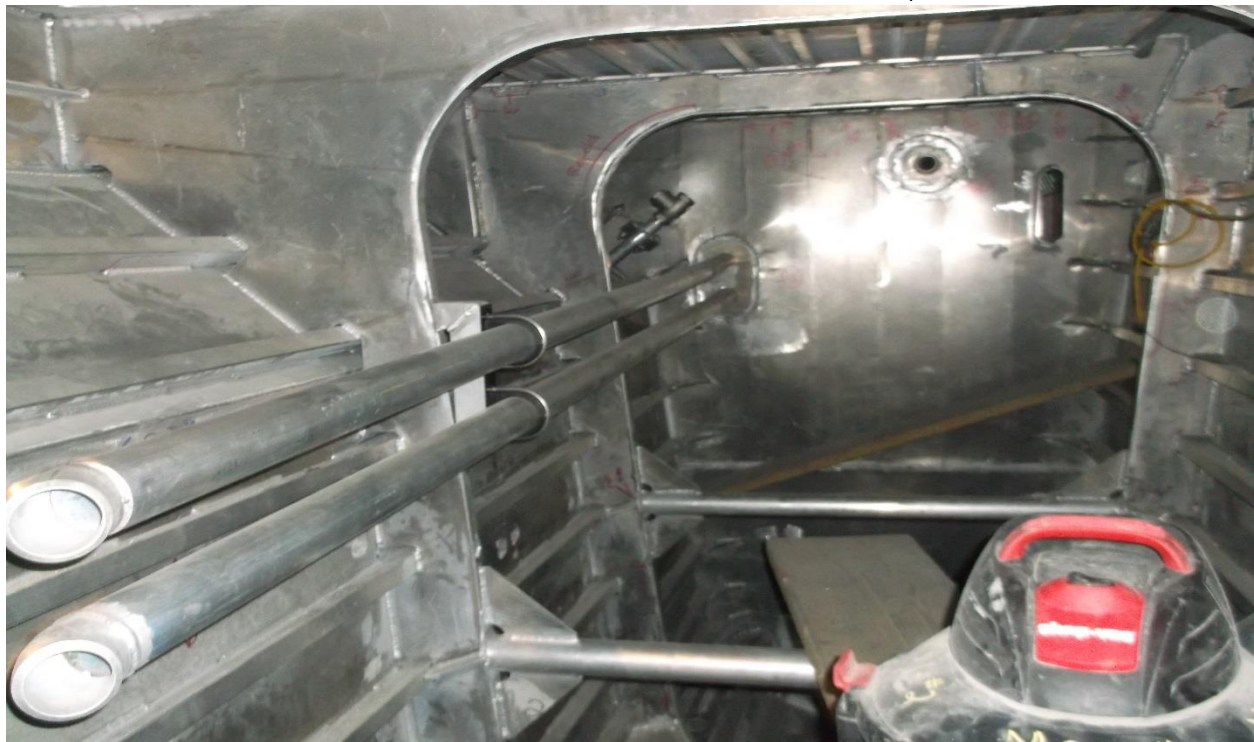
Forward view of above photo having fuel oil piping installed through bulkhead up to tank
